Cardiology Clinics

Transesophageal Echocardiographic (**TEE**) Evaluation of Prosthetic Valves

David S. Bach MD

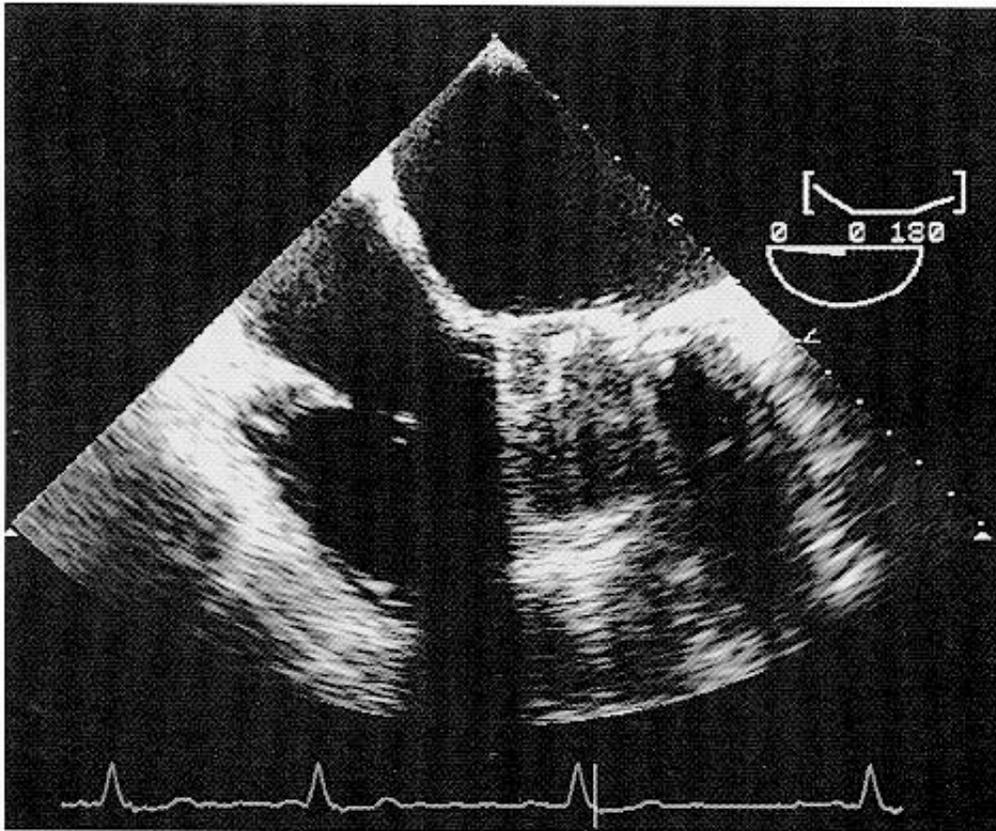
Figure 1. Ultrasound-imaging artifacts associated with mechanical prosthesis in mitral position. Reverberation artifacts appear as redundant echoes distal to prosthesis. Mirror-image artifact appears as second iteration of prosthesis displayed at twice the distance from the transducer. Acoustic shadowing results from loss of ultrasound penetration beyond prosthesis.

The presence of a valve prosthesis does not inherently alter the general approach to the transesophageal assessment of valve anatomy and function; however, acoustic properties associated with nonbiologic components of prosthetic heart valves affect the echocardiographic examination. Mechanical prostheses and the ring of stented bioprosthetic valves contain components made of metal, plastic, or pyrolytic carbon. These materials are strong reflectors of ultrasound energy, resulting in ultrasound attenuation and imaging artifacts. Attenuation of ultrasound energy results in insignificant ultrasound energy penetration distal to the prosthetic materials, obscuring regions distant to the valve. Reverberation artifacts are caused by multiple reflections of the ultrasound beam between the prosthetic valve and the ultrasound transducer or between two or more echo-reflective components within the prosthesis, possibly because of the large amount of ultrasound energy reflected by the prosthetic components. Reverberation artifacts associated with valve prostheses appear as a series of bright echoes originating at the location of and extending distal to the valve. A specific type of reverberation artifact results in a mirror artifact, in which reflection of the ultrasound beam between the prosthesis and the echocardiographic transducer results in second or third images of the prosthesis displayed at multiples of the distance between the prosthesis and the transducer. Side-lobe artifacts occur in conjunction with prosthetic valves, similar to their occurrence with any strong ultrasound reflector. An example of imaging artifacts associated with a mechanical mitral prosthesis is shown in [Figure 1](#).

Signal attenuation and reverberation and side-lobe artifacts occur because of the strong echo-reflective properties of prosthetic materials used in artificial valves. An additional artifact occurs because ultrasound energy is transmitted at a different speed through prosthetic materials than through soft tissue. The ultrasound image is oriented in space and calibrated to distance based on the speed of sound. The depth of an object from the transducer is determined by the time interval required for sound energy to travel to and from the object and the known speed of sound through soft tissue. Sound energy that is propagated more rapidly

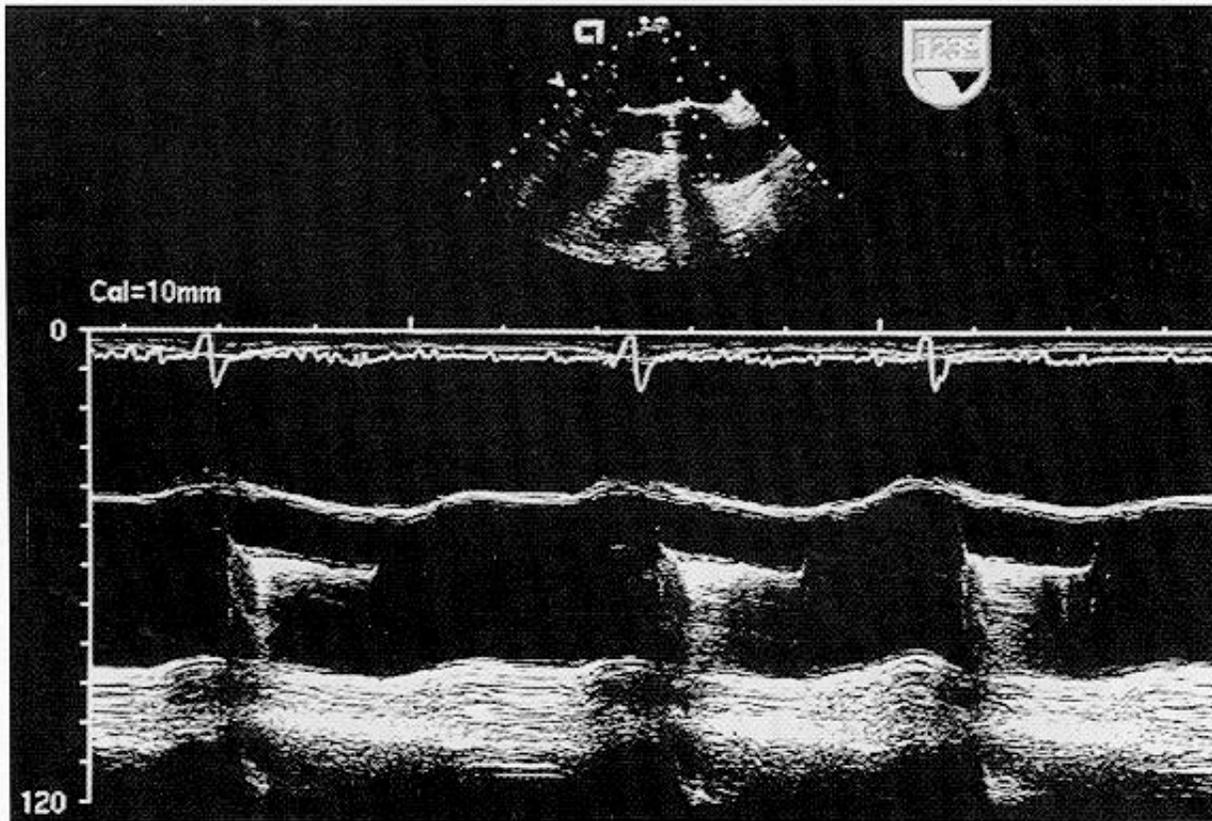
Figure 2. M-mode transesophageal echocardiogram (TEE) of prosthetic aortic valve disk motion. Vertical lines demonstrate rapid disk movement between open- and closed-disk positions.

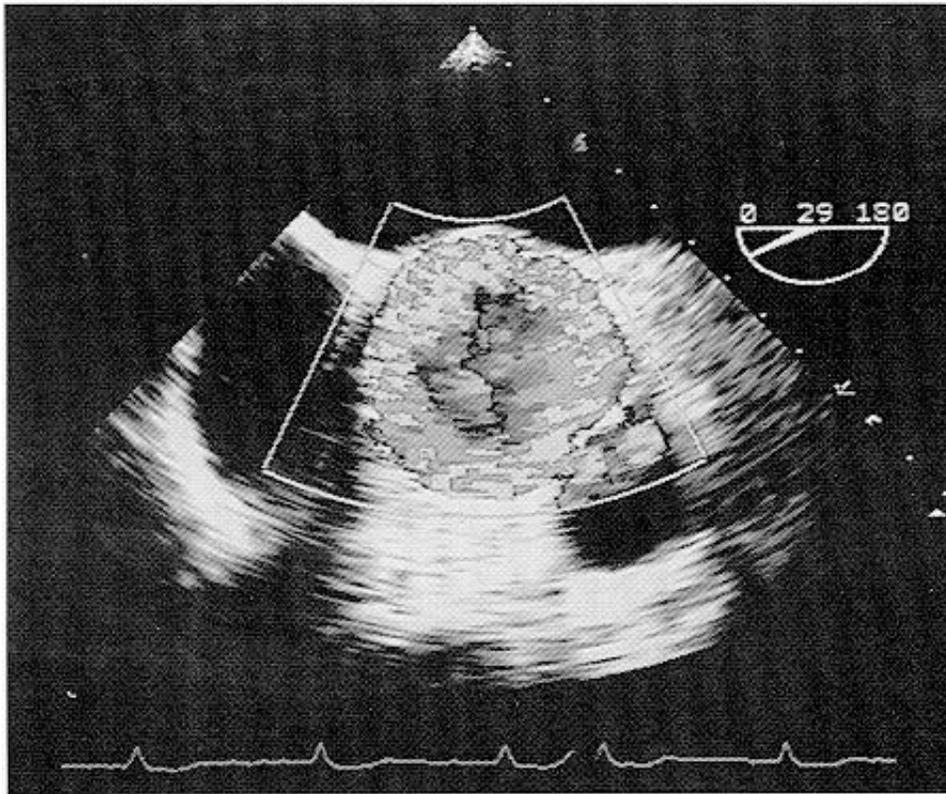
Figure 3. Turbulent antegrade flow through caged disk valve. Imaged in short axis above the prosthesis, turbulent flow enters ascending aorta around the circular disk occluder. A caged ball valve with similar flow can be distinguished by higher profile cage mechanism in long-axis view.

Although it gained only limited clinical use, a caged disk (Cutter) valve is encountered occasionally. An example of flow through this valve is shown in Figure 3. The valve is constructed with a caged disk occluder oriented perpendicular to flow. The circular pattern of turbulent forward flow is similar to that observed with a caged ball prosthesis, although the caged disk valve can be differentiated by its lower

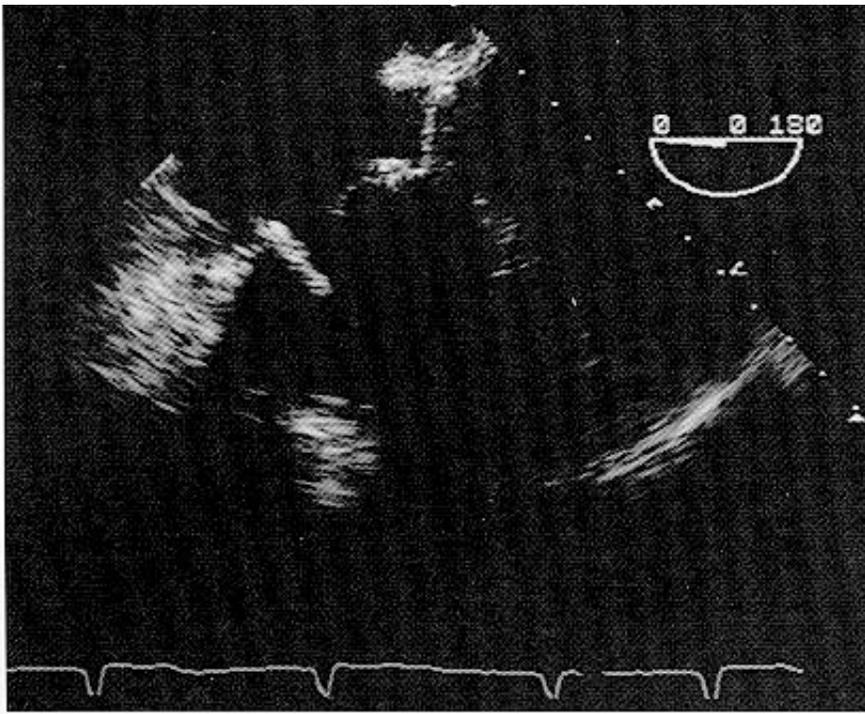
Figure 4. Bioprosthesis in tricuspid position. One of three support struts is imaged in this view. Valve leaflets are thin and of soft tissue density.

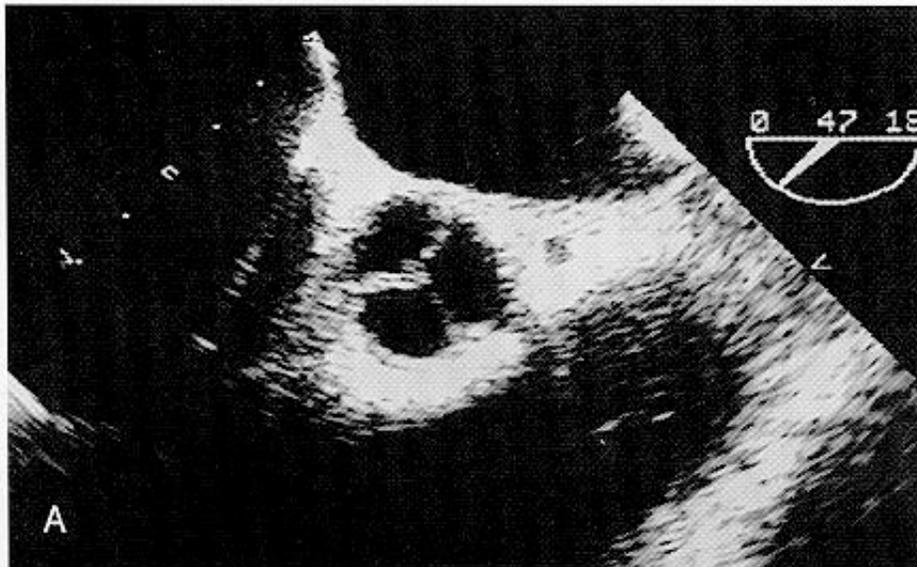
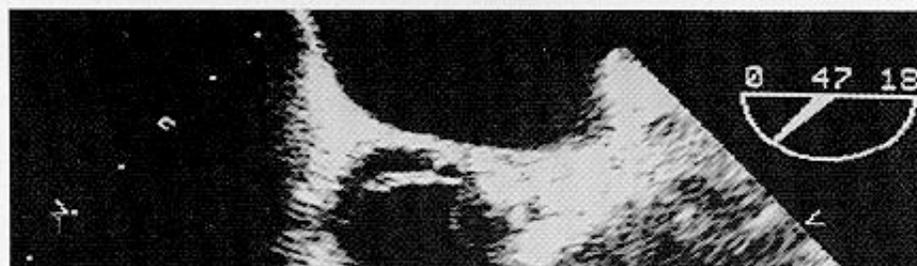
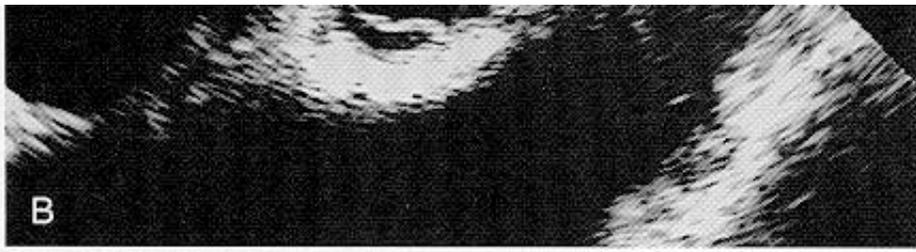
Figure 5. Short-axis view of stentless aortic bioprosthesis (subcoronary implantation) in diastole (A) and systole (B) reveals normal appearance of valve cusps and minimal paravalvular thickening.

As anticipated from the surgical anatomy, the echocardiographic appearance of the full root stentless bioprosthesis is remarkable for an essentially normal appearance of the ascending aorta, because there is only a single layer of aortic wall circumferentially. The echocardiographic appearance of these prostheses may closely imitate normal, and patients following full root stentless aortic valve surgery may be identifiable as other than normal only if there is evidence of focal thickening at the inlet or outlet suture lines. Patients following root inclusion stentless aortic valve implantation typically represent the opposite end of the spectrum of the echocardiographic appearance of the ascending aorta. Among these patients, there is a double layer of aortic wall circumferentially in the first few centimeters of ascending aorta, resulting in a variable degree of thickening of the aortic root evident on **TEE**. Following complete subcoronary implantation of a stentless aortic valve, minimal soft tissue thickening of the aortic wall can be evident on **TEE**. Retention of the noncoronary sinus of Valsalva with modified subcoronary implantation of a stentless aortic bioprosthesis results in a characteristic appearance on **TEE**, with soft tissue thickening of the aortic root limited to the noncoronary sinus of Valsalva and small adjacent areas of the right and left sinuses of Valsalva. Examples of the **TEE** appearance of stentless aortic bioprostheses are shown in [Figures 5 and 6](#).

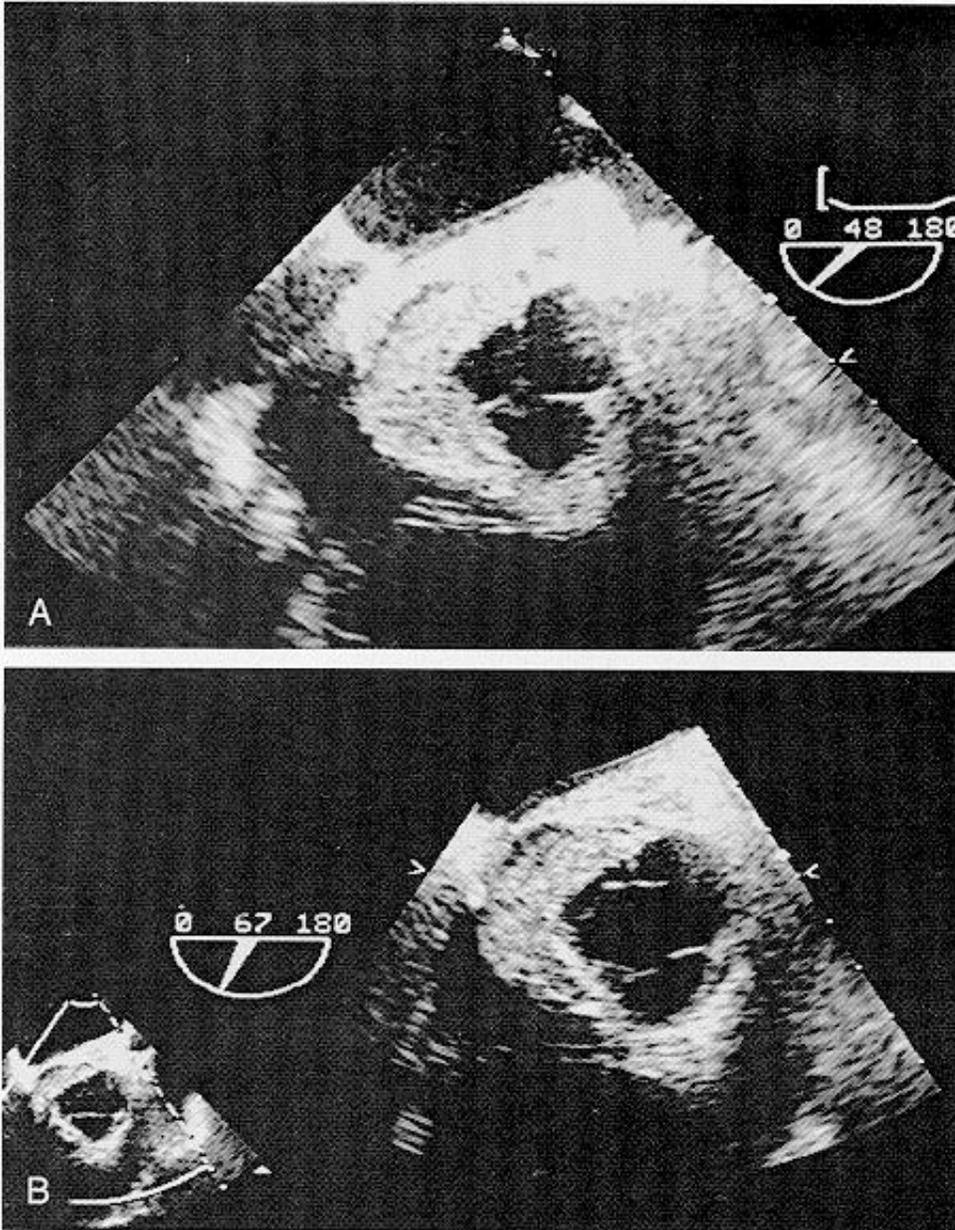
Figure 6. Short-axis view of stentless aortic bioprosthesis (modified subcoronary implantation) in diastole (A) and systole (B). Cusps appear thin and demonstrate normal systolic mobility. Paravalvular soft tissue thickening is confined to region of noncoronary cusp, accumulating in space between native ascending aorta and retained noncoronary sinus of Valsalva.

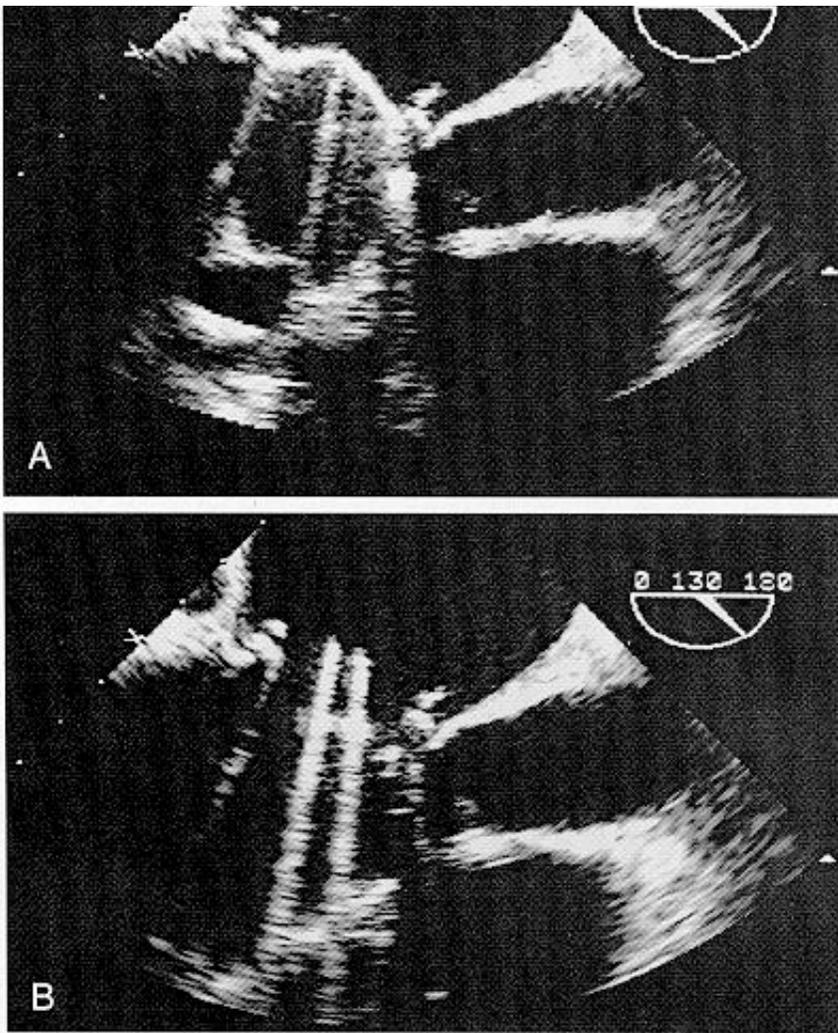
Figure 7. Long-axis view of dual disk valve (St. Jude Medical [St. Jude Medical, St. Paul, MN]) in mitral position. Valve is in typical “anatomic” orientation, with pivots placed at location of normal anterolateral and posteromedial commissures. Both disks are identified in closed position in systole (A) and open position in diastole (B).

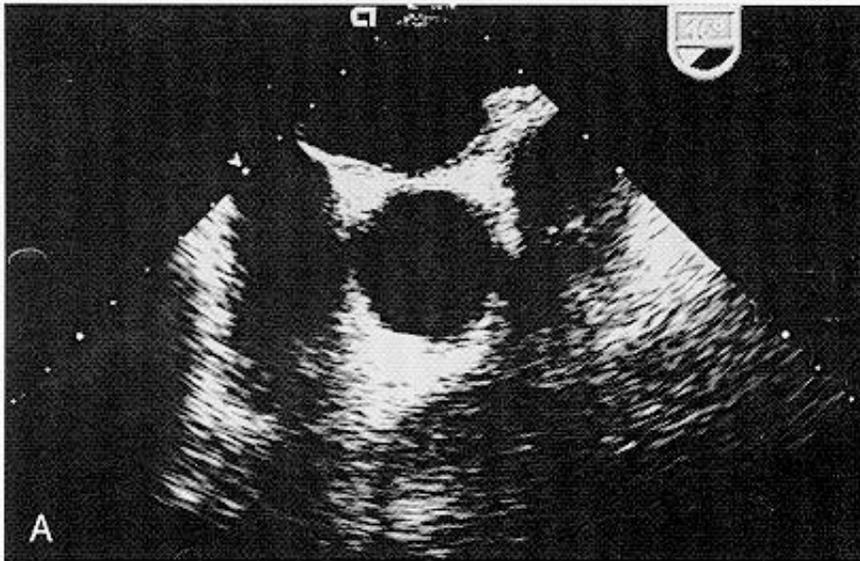
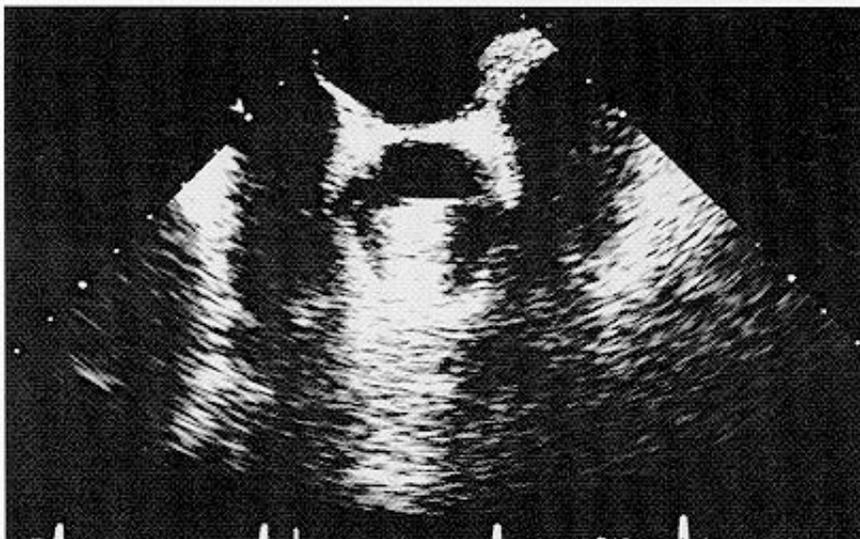
Figure 8. Short-axis view of single-disk valve (Medtronic Hall [Medtronic, Minneapolis, MN]) in aortic position. Imaging is just above level of annulus, and disk is not seen in closed position during diastole (A). During systole (B), open disk is oriented perpendicular to ultrasound beam.

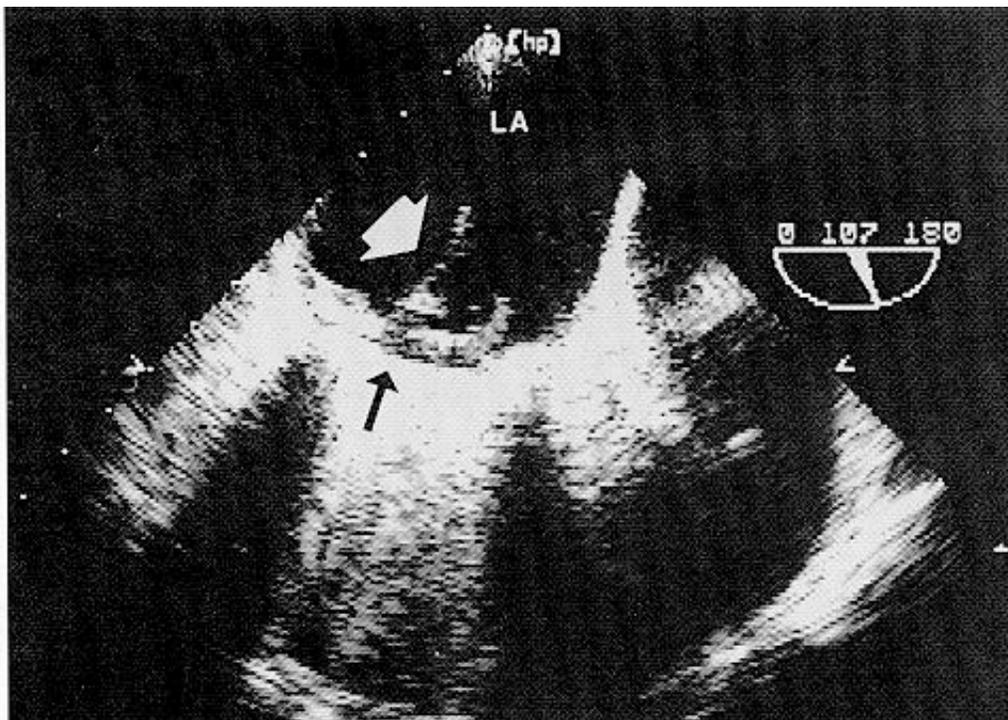
Figure 9. Vegetation (*white arrowhead*) on left atrial aspect of mechanical mitral prosthesis. Reverberation artifact (*black arrow*) obscures detail distal to prosthesis, and precludes visualization of vegetation from transthoracic windows.

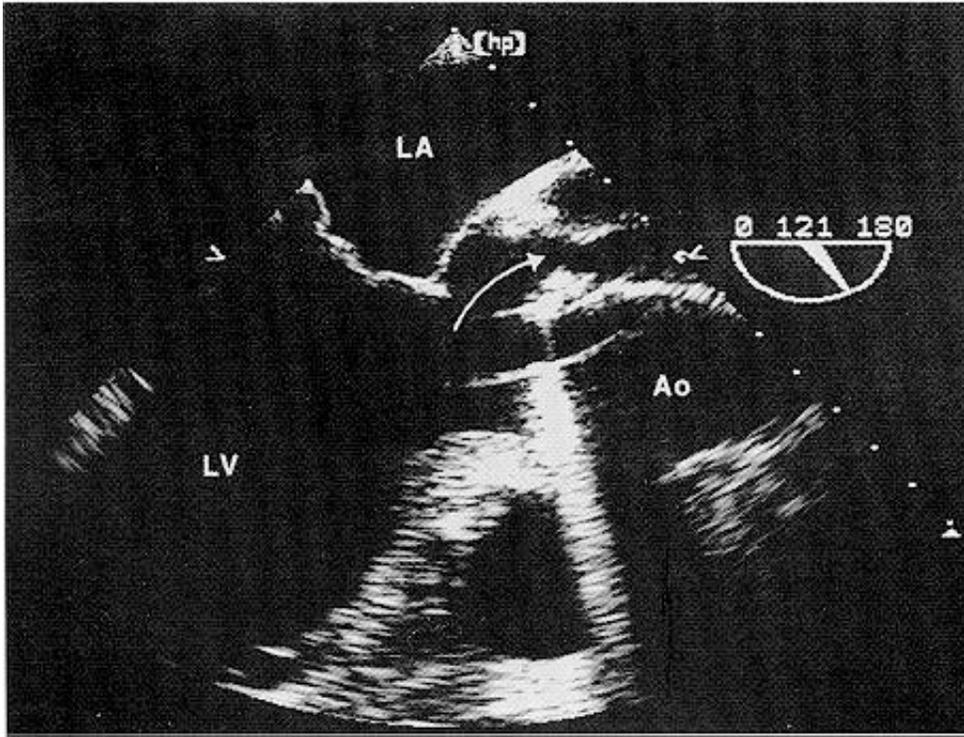
Figure 10. Long-axis view of left ventricular outflow tract (LVOT) and ascending aorta, demonstrating dehiscence (*arrow*) of valved aortic root composite graft complicating infective endocarditis.

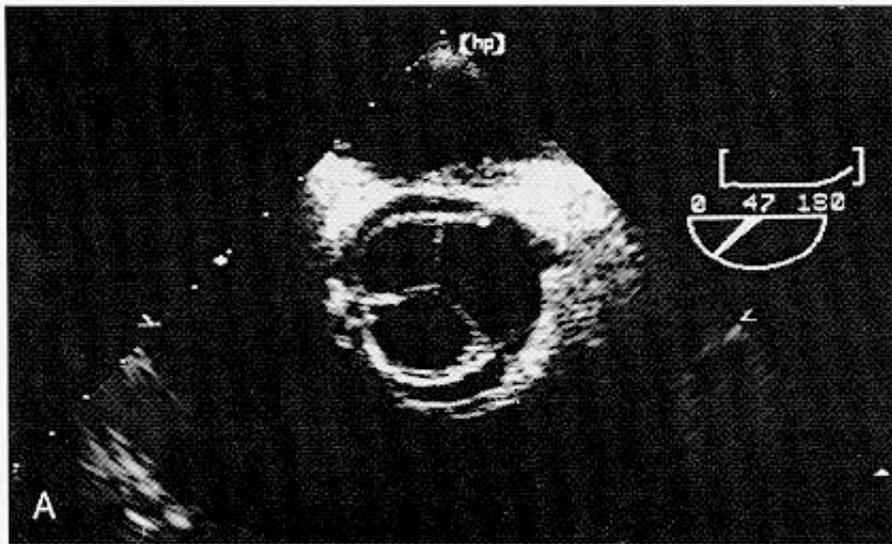
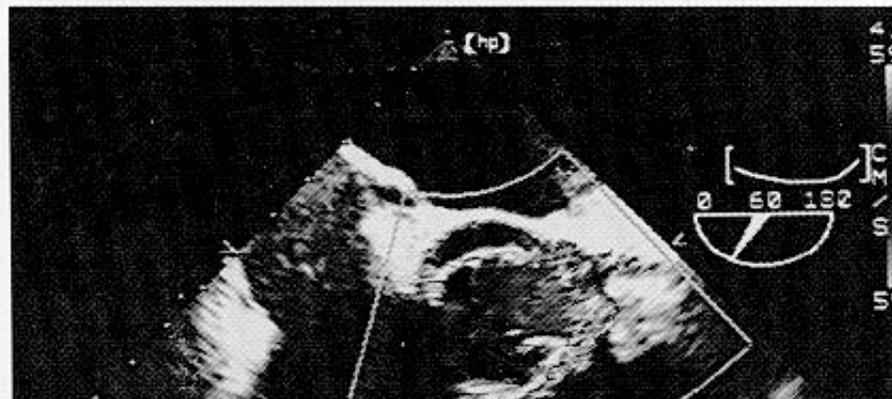
Figure 11. Short-axis view of stentless aortic bioprosthesis with partial dehiscence (A) and broad-based paravalvular aortic regurgitation jet (B).

Sufficient paravalvular tissue destruction complicating prosthetic valve endocarditis can result in partial or complete valve dehiscence. On **TEE**, prosthesis dehiscence sometimes can be detected as an abnormal rocking motion of the prosthesis independent of its surrounding structures. An example of dehiscence of an aortic valve prosthesis is shown in [Figure 10](#). Prosthetic valve dehiscence is accompanied by significant paravalvular regurgitation. The finding on **TEE** of a broad-based paravalvular regurgitant jet emanating from a significant portion of the circumference of the prosthesis suggests partial valve dehiscence; the extent of the valve's circumference from which the jet emanates is a marker for the extent of dehiscence. An example of a broad-based paravalvular regurgitant jet associated with prosthetic aortic valve endocarditis is shown in

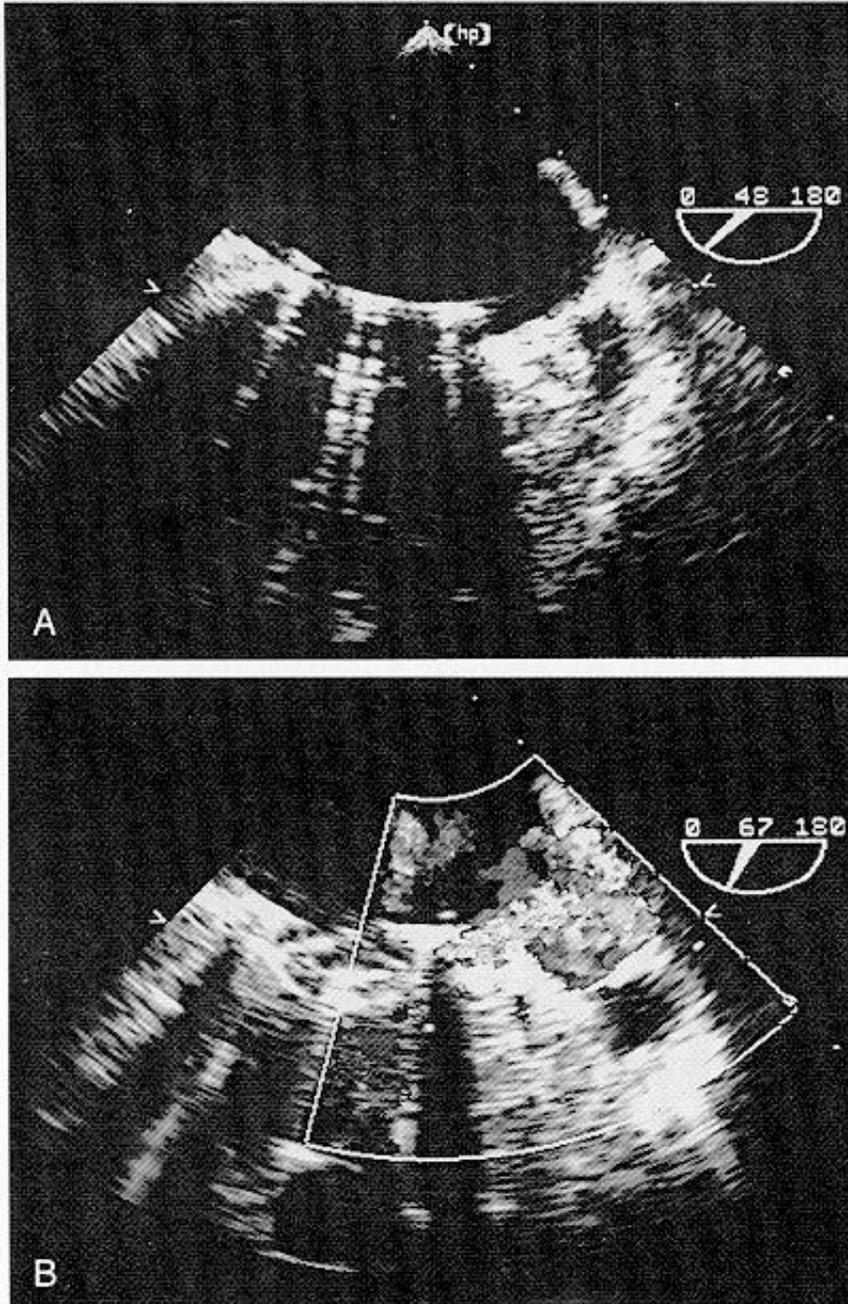
Figure 12. Dual-disk mechanical mitral prosthesis open during diastole (A), with paravalvular mitral regurgitation (B). Paraprosthesis regurgitation impacts left atrium near left atrial appendage.
